FINAL
SITE INSPECTION PRIORITIZATION (SIP)
LETTER REPORT
IBM COUNTRY CLUB
DUTCHESS COUNTY, NEW YORK
CERCLIS NO.: NYD982531907

APRIL 1995

**IBM COUNTRY CLUB
SOUTH ROAD
TOWN OF POUGHKEEPSIE, DUTCHESS COUNTY, NEW YORK
CERCLIS NO. NYD982531907**

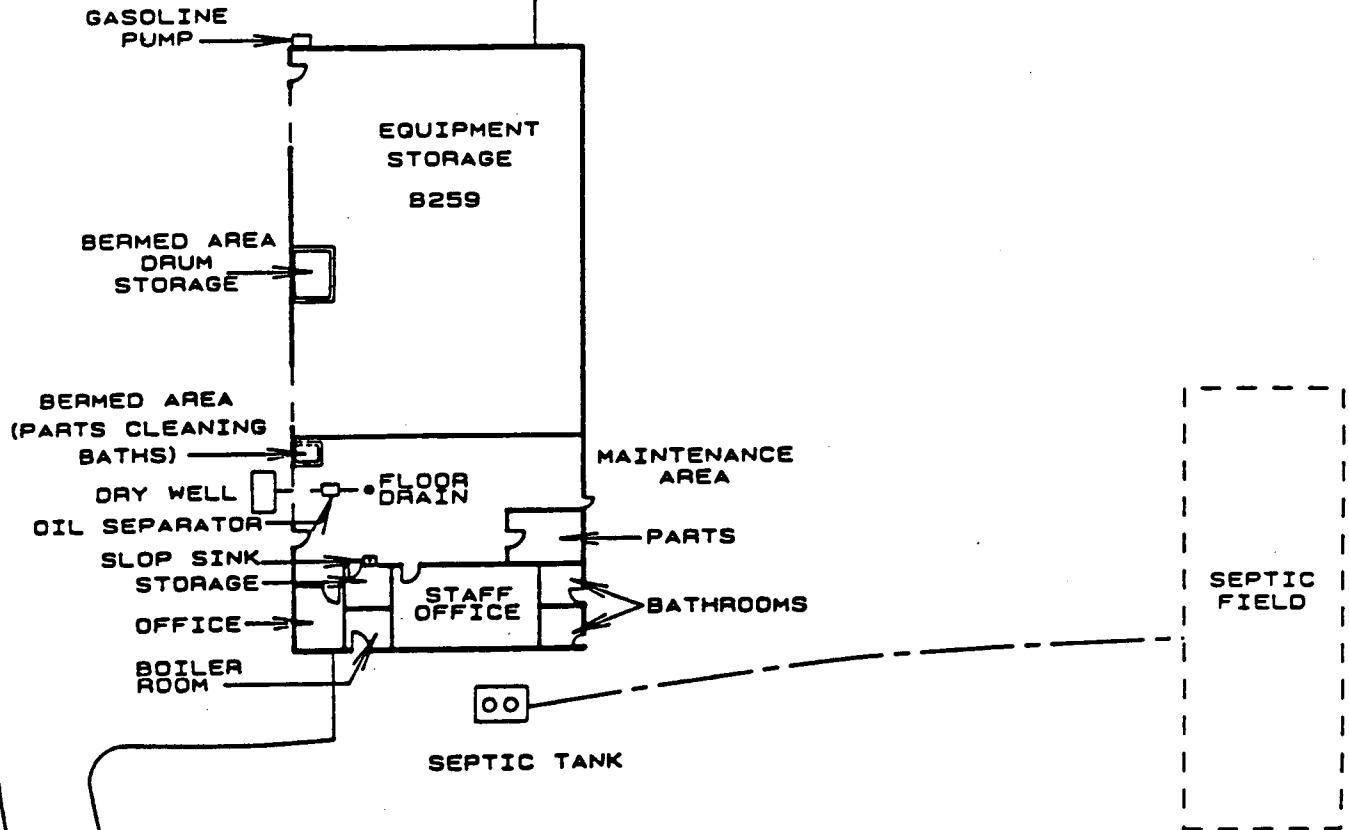
FIGURE 2
SITE B259 MAINTENANCE BLDG.
IBM COUNTRY CLUB
POUGHKEEPSIE, NY

SOURCE: HYDROGEOCHEMICAL ASSESSMENT OF
B259 COUNTRY CLUB MAINTENANCE
BUILDING AREA, MARCH, 1988.
